Poke-Yoke Bodyshop

LTG Symbol rotation

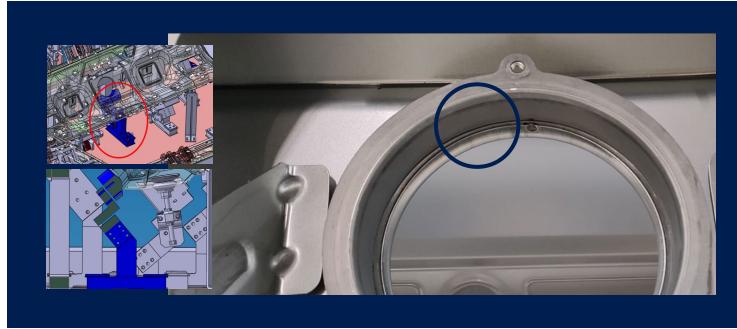
After

This improvement created a welding fix between the two parts, making it impossible to create rotation between them and cause a problem.

- The symbol bracket position was only assured in the Paintshop oven, where the structural glue cured.
- Due to the manual handling operations during the construction process, there was a risk of rotating the symbol bracket unintentionally.
- Add a Weld point in the stosspunkten station
