Cosmetic sealer

Application automation

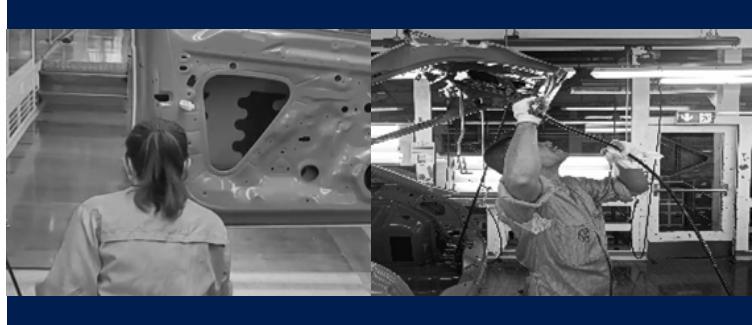
Before

- Manual sealer applications were conducted for several processes leading to potential quality faults, reworks with added ergonomic impact due to lack of accessibility.
- In-house developed automatic application with increased quality output, reducing the needs of additional reworks. Improved ergonomic score. Optimized application areas: A/B/C Pillars; Doors; Hood; Liftgate; Sides; SBBR; Water box.
