Primer engine compt

Manual application deletion

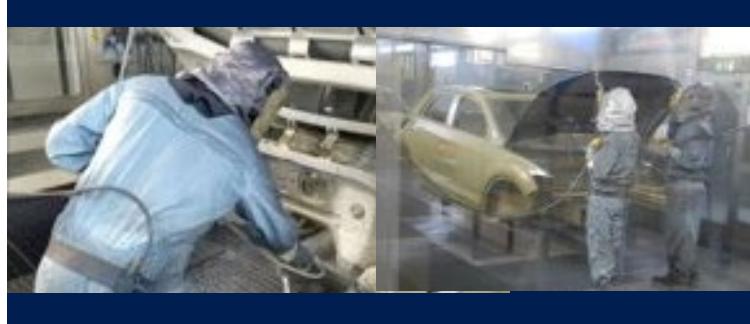
Before

- Manual primer applications leading to potential quality faults and reworks. Working stations with relevant ergonomic score (orange station) due to worker's position during the primer application.
- Need for TAG relief operation in primer line.
- In-house developed automatic primer application with increased quality output, reducing the needs of additional reworks. Improved ergonomic score (deletion of orange station). Workloads and line balance adjusted with increased productivity. Optimized application areas: Engine compartment; Hood
