# Adhesive Waste Reduction

## Environmental Impact

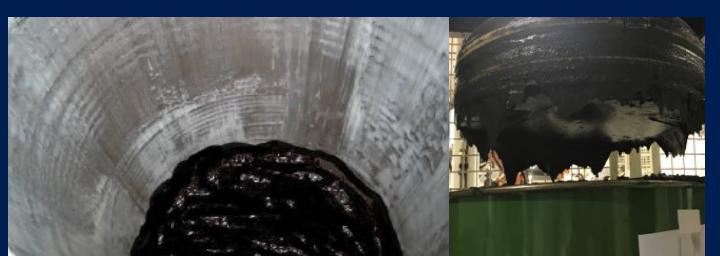
### Before

3,5 – 7L waste (remaining glue)

- The pump plate cannot go all the way down because it sucks the plastic bag into the pump and causes malfunctions. It had to be adjusted higher up, which meant more adhesive was wasted at the end of the barrel.
- The implementation of a perforated accessory in the pump plate prevents the plastic from entering and allows the sensor to be adjusted completely downwards, reducing adhesive waste. For the 25 Kg drums, an inhouse developed drilled pump plate was implemented.

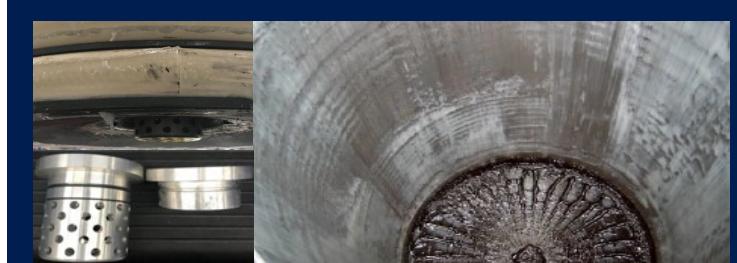
### After

85,7% less waste (1L remaining glue)
